The Effects of Plastered Skin Confinement on the Performance of Straw Bale Wall Systems

Adrienne Wheeler, David Riley and Thomas Boothby
Pennsylvania State University

Summer Research Opportunities Program 2004

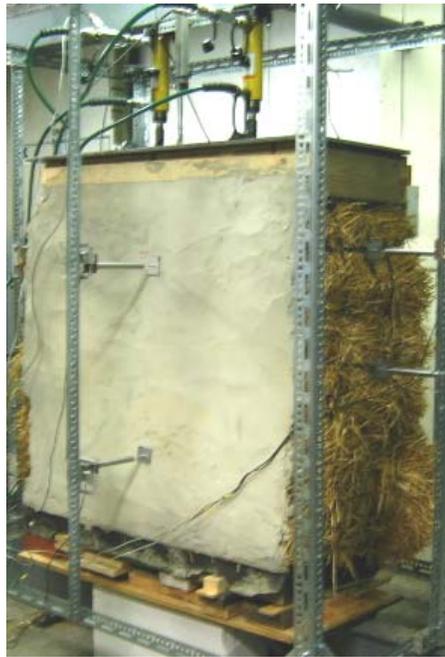
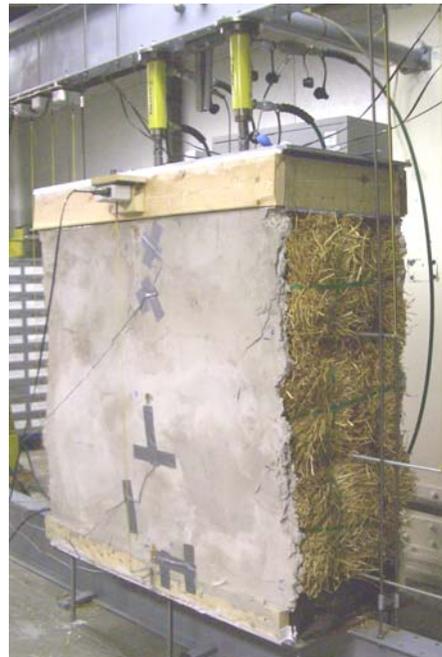
Laboratory test conducted by David Riley and students in 2003-2004, at Pennsylvania State University, showed some of the benefits to confining plaster skins. In this program, they tested walls with moderately confined skins and walls with completely confined skins. The test specimens were four feet long three bales high plastered straw walls. The bales were pinned with rebar, sandwiched in 17-gauge wire mesh using pins, and plastered with cement stucco. Each wall had top and bottom box beams placed on them that were strapped to the bales with polypropylene strapping. On the top of the upper box beam laid a steel plate to evenly distribute the load to the bales. The entire specimen rested on a bottom plate that had threaded rods connected to the floor. The stucco was confined with Z-channel on the top of the skin and J-channel on the bottom. The confined specimen had additional 2x6 and 2x4 battens along the top and bottom of the plaster skins (Figure 4.2a). The other specimen did not have the extra batten on the bottom of the skins for support (Figure 4.2b), so the skins rested solely on the J-channel. Two 20 kip hydraulic pumps electronically applied the load pressure to the walls. Both specimens under went compression tests. The testing frame to which the specimens were hooked up comprised of the potentiometers three along either side and two, front and back. Strain gauges were also placed vertically along the front and backside of the wall.

Figure 4.2- Unconfined(a) and Confined(b) test specimens

During the compression test with moderate confinement the total wall system withstood about 7,000 pounds, and the skins vertically sheared off the lathe. In the first case of complete confinement the wall failed at about 16,000 pounds and the skins remained in place with minor cracking. This specimen also continued to fall forward as greater load was applied. The second fully confined specimen tested did not reach failure in the lab. At a load of 20,000 pounds the specimen incurred little cracking in the plaster, and stood perfectly erect. The second specimen compares quite well with the highly reinforced specimen in Cale Ash's test which withstood 19kips.

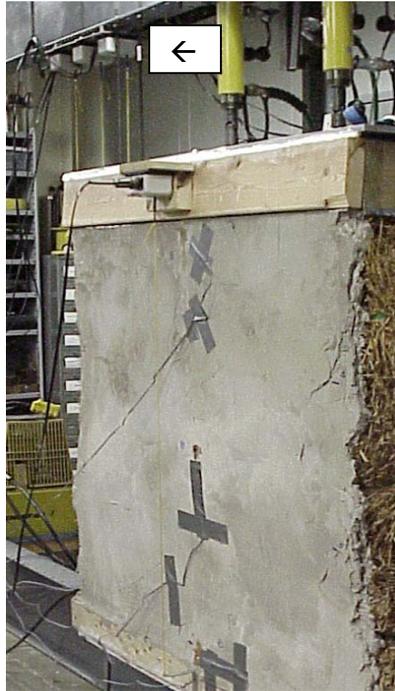
The potentiometers connected to the wall specimen in the completely confined test incurred technical difficulties. Before the test began it was hypothesized that the bottom potentiometers would receive the biggest recording of deflection, since all loads were being applied from the top of the wall and transferring downward.

Figure 4.5 potentiometers attached to testing frame

It was also assumed that the wall would hold more than the wall with moderate confinement. The middle potentiometers did not give any recording of data on either side of the wall, which would infer there was no deflection in the center of the bale. This conclusion however is unreasonable to assume due to the unlikely hood of a wall deflecting on the top and bottom with out going through the center. The illogicality of the graphs is explained by the potentiometers being secured to the testing frame and not the actual test specimen (Figure 4.5). This setup allows for the potentiometers to record the movement of the frame in addition to the deflection in the wall, which is not what researchers were looking for in this test. To address this issue, the

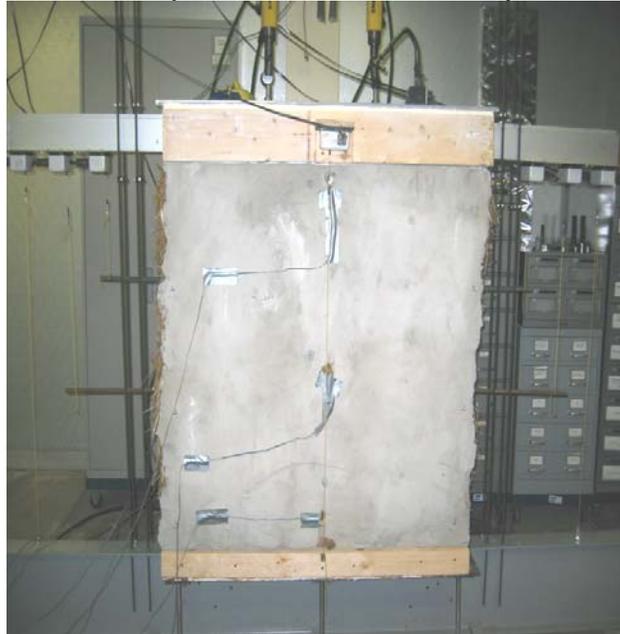
second test specimen had the potentiometers attached to the upper box beam of the wall instead of the testing frame (Figure 4.6), in an attempt to eliminate the bias incurred from the frame during the previous test. Despite the fact that the data did not come out as clear in the first test of complete confinement, there is assurance that the results for the second specimen, when made available, will be very accurate. Even without the exact load versus deflection pattern it is evident that the wall held substantially more than the moderately confined specimen.

Figure 4.6 – Improved test setup with potentiometers attached to box beam

Placing additional supports on the frame, kept the frame in place as load was applied to the wall. Having a steady setup applying load, allows the load to transfer directly into the wall and not to the frame. This test gives a more accurate picture of what a well confined wall can do. The moderately confined skins withstood 7kips on J-channel alone. This shows that J-channel is just the beginnings of obtaining a well built wall. Just the addition of one 2x4 tripled the holding capacity of the wall. This experiment only strengthens the reason why skins should be placed on the foundation of straw bale structures. Other methods to look into when testing plastered wall is placing the wall close to the ground, and letting the skins rest on the floor. A test of this nature would give the most realistic results compared to setting skins on the foundation on construction sites. Also conducting test with wall assemblies that have fully confined skin on one side and unconfined skin on the other, will give researchers an idea to how “half confinement” works compared to confinement of both sides. Results from a test of this kind can address the question, is there a possible long-run disadvantage to only confining interior skins, and if not what makes confining only one skin work? Until these questions are addressed the best and most reliable method of confining plastered skins is to place both skins on the foundation of the structure. So far this is the only full proof method of allowing the skins to transfer roof loads directly to the foundation.
