# A Pilot Study examining and comparing the load bearing capacity and behaviour of an earth rendered straw bale wall to cement rendered straw bale wall.

Michael Faine and Dr. John Zhang  
University of Western Sydney, Australia

**ABSTRACT:** During the last two years two straw bale walls were built and load tested to failure. One wall was constructed using a cement based render and the other with an earth based render. The walls were constructed in the University's loading frame and subjected to uniformly distributed compression loads applied to the top plate. The methods of construction for both walls were similar; using bales sourced from the same farm. The test results were noted and compared with the earth rendered wall behaving in a similar manner to the cement rendered wall. There was a small difference in the load carrying capacity of the earth rendered wall.

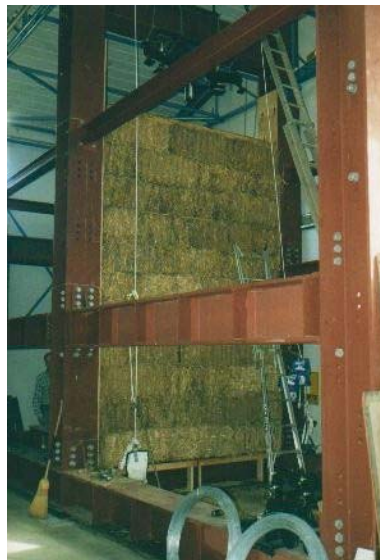
**Figure 1** General view of steel test frame and partly completed wall for two-storey wall (Photograph: P. Florence)

The loading frame was used to contain the construction of the straw bale wall(s). Figure 1 shows the general frame arrangement with the partly completed two-storey straw bale wall framed between the large structural steel columns. The steel beams and columns were fabricated from 25mm thick steel, 400 x 400mm “I- beam” section, courtesy of a research grant and BHP steel sections.

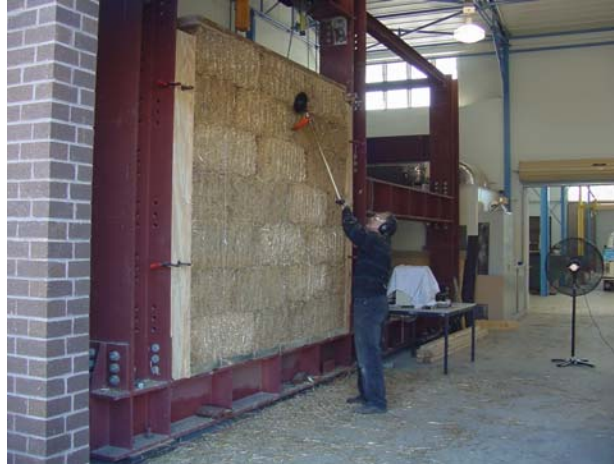
**Figure 3:** General view of earth rendered straw bale wall at time of trimming. (Photograph S.Overmeyer)

The straw bale wall was 7 bales high by 3 bales long but was not pinned with rebar nor was a chicken wire mesh used to cover the face of the straw. The bales were pre-compressed by 80 mm prior to the test being carried out. A general view of this wall being trimmed to size can be seen at Figure 3.

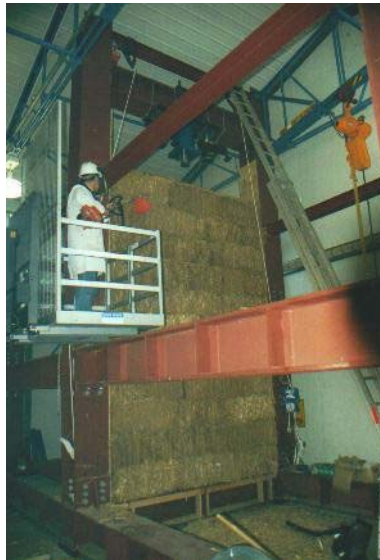
**Figure 4:** Trimming two-storey bale wall to size. (Photograph P. Florence)

The wall was trimmed to remove stray fibres and nocked into a reasonable straight line prior to the wall being compressed. Once the team was satisfied with the result the rendering process began. Two coats were applied over a period of two weeks, with the coats being applied in about a day and a half by a team of four (inexperienced) renderers. The mix design was 1: 4: 0.5 being cement: sand: lime. This was a strong mix with the addition of the lime to 'self heal' any later cracking. The rendering process for the two-storey wall can be seen in Figure 5.

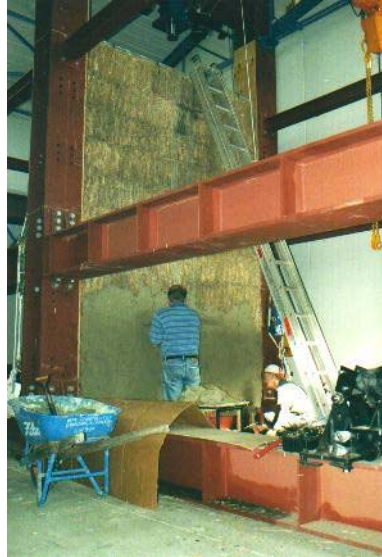
**Figure 5:** Render application over mesh for two-storey wall. (Photograph P. Florence)

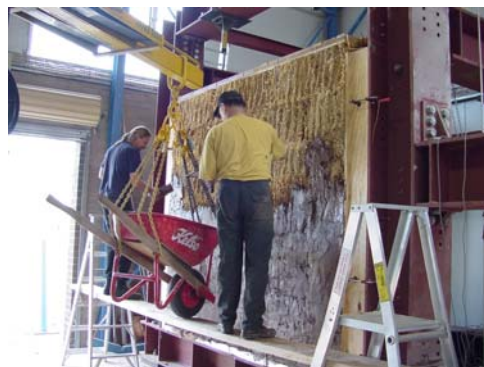
**Figure 6:** Earth render application. (Photograph P. Florence)

A similar method was used to apply the earth based render. The mix design was 3:3:1 being earth: river sand: chaff for two coats (about 35-40 mm thick total) and the finish coat mix design was 3:3:1:0.6 being earth:sand:slaked lime:chaff for a final coat thickness of about 3-5mm. The earth based render was easier to apply direct to the straw wall, which had been

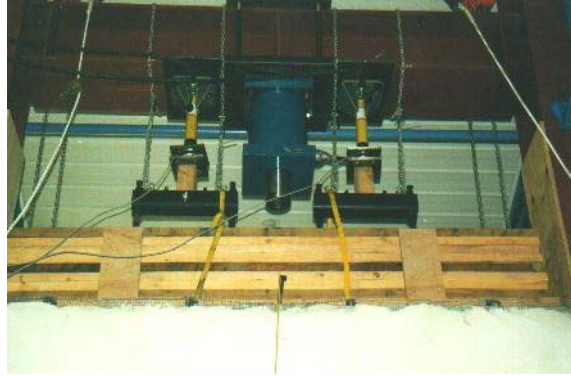
**Figure 7:** Hydraulic rams and top plate assembly for two-storey wall.  
(Photograph P. Florence)

The test set up was fairly simple. Two 10 tonne capacity Enerpac hydraulic rams were coupled together and attached to the top steel reaction frame. 2 x 10 tonne load cells (HBM Agezelle) were placed in between the ram and steel spreader bars designed to distribute the

load at 450 mm centres were stacked on top of the plate. The general arrangement can be seen in Figure 6 for the two-storey wall and at Figure 7 for the earth rendered wall.

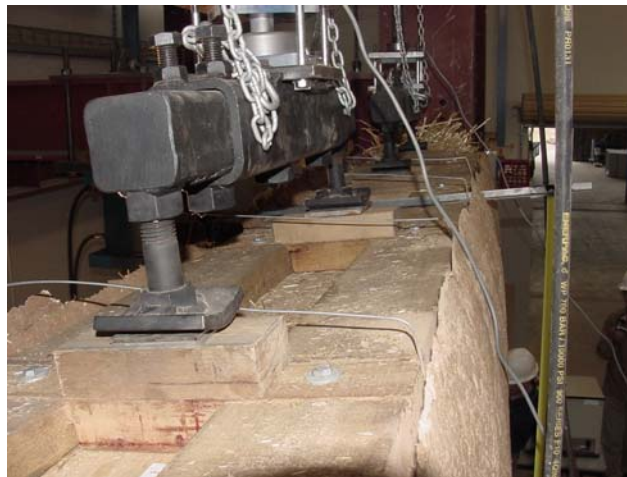
**Figure 8:** Hydraulic rams and top plate assembly for earth rendered wall (after test).  
(Photograph P. Florence)

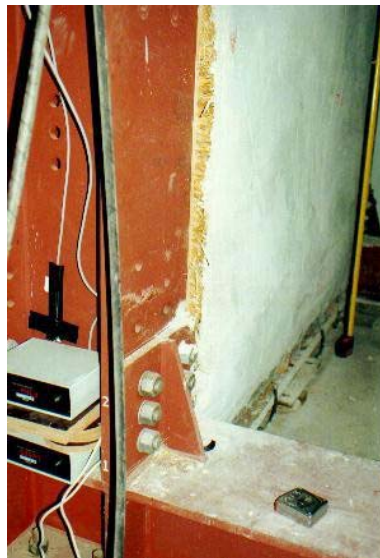
**Figure 10:** View of electronic display units and end of tape. (Photograph P. Florence)

The load cells were calibrated and the two electronic display units were set up to give a read out of the load from each hydraulic ram in newtons. During the test(s) the readout from each unit would be noted against time and deflection/deformation of the wall(s). A steel scale had been attached to either side of the wall(s) at the midpoint and this was to be read against a static point set up from the floor of the laboratory. Figure 9 shows the steel scale attached to the top plate of the two-storey wall and Figure 10 shows the data acquisition units. The set up was similar for the earth rendered wall test and can be seen at Figure 11.

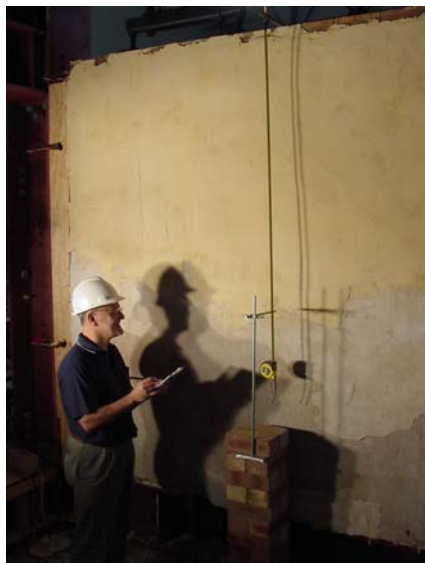
**Figure 11:** View of deflection measurement process for earth rendered wall. (Photograph P. Florence)

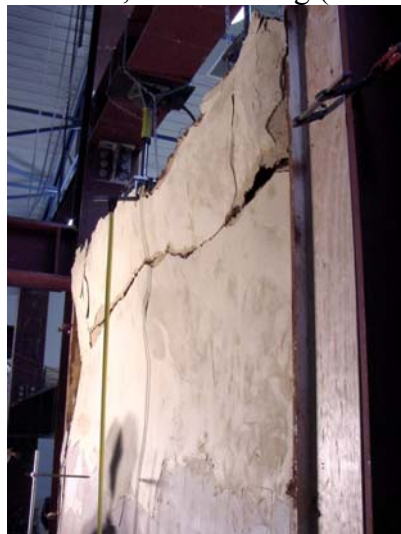
**Figure 15:** Earth rendered wall after test, note cracking (Photograph S.Overmeyer)

A significant difference between the two tests was that the earth rendered wall showed more obvious signs of compression, both by sound and by the appearance of cracks when compared to the cement rendered two-storey wall. The time involved in this test was of a much shorter duration when compared to the two-storey wall test, taking only about 16 minutes before the test was stopped. By this time the wall had a number of severe cracks and delamination of the render. This can be seen at Figure 15.

The earth rendered wall was much more spectacular in its failure mode, more visible cracking and spalling of render and more noise associated with increase in load and less time to failure. This resulted in a number of large cracks and rotation of the top plate, probably due to a differential settling from one side to the other.

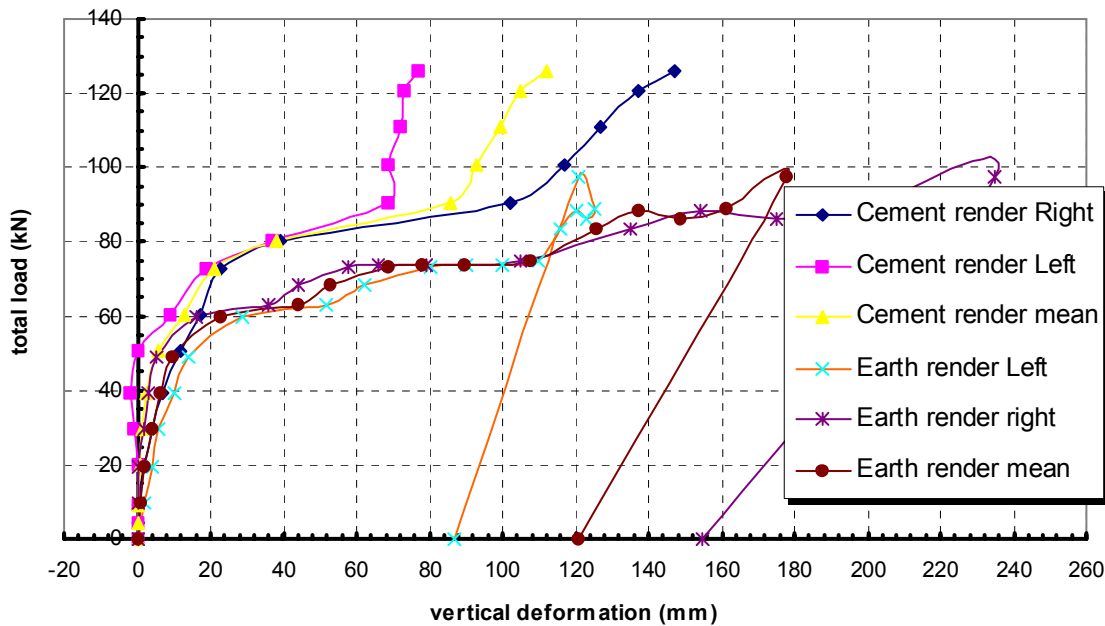
The following graph shows the results for both walls for load versus vertical deformation. The curve for both tests reveals a classical material behaviour with a yield point for both walls as the curve changes to a more horizontal line.

**Figure 16** Load Deformation Curves for both walls (Source J. Zhang)

The two-storey wall demonstrated some interesting and fascinating structural characteristics. Apart from the obvious failure region when the load reaches about 80 kN, it also reveals that the post-failure behaviour has a distinct feature of post-stiffening effect due to the compressibility of the material.

When the wall is first loaded, the behaviour follows a typical linear path. The left side deformation reading is negative indicating it is moving upward instead of downward as one would expect. This is due to the eccentricity in the applied load and in the wall itself. This eccentricity creates a significant bending effect so that the wall is bent toward the right hand side.

For this reason the average deformation between the left and right sides provide a more meaningful interpretation of the result. It can be seen on the average curve at the load level of just above 40 kN, there is a significant increase in deformation, demonstrated by the change of slope in the curve. One would stipulate that due to the compression of straw bale, the interaction between the straw and the cement render becomes less significant resulting in the 'softening' of the wall. As the load increases the wall starts to 'yield'. At the load level of 70 kN there is a significant increase in deformation, which marks the failure of the wall. This failure is probably due to the significant separation between the straw bale and the cement render. As the load increases further, the straw bale becomes fully compressed, therefore

becoming more solid as the load starts to increase further. Although this post-failure capacity cannot be used in the design of straw bale wall, it does illustrate that the post-failure behaviour is rather stable.

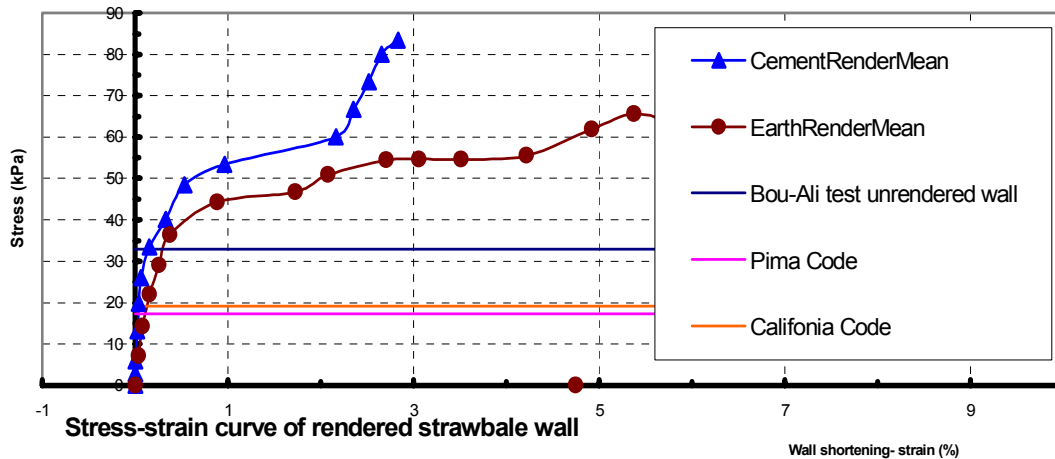
**Figure 17** Stress (in kPa) versus wall shortening strain. (Source J.Zhang)

The maximum allowable stress that a straw bale wall can support depends on a number of factors. Of these the wall slenderness (height/thickness) and the unsupported length ratio (unsupported wall length/thickness) are the major influencing factors. The Pima County, Arizona, Straw bale building code limits h/t ratio to 5.6 and L/t ratio to 13. The maximum permissible stress provided by the straw bale alone is limited to 2.5 psi (17.24 kPa) in the Pima Code. California’s model straw-bale code allows an L/t ratio of 15.7 and a maximum allowable load of 2.77 psi (19.10 kPa).

These allowable values are for straw-bale alone. Virtually all straw-bale walls are rendered, the contribution by renders is significant, however this contribution is difficult to quantify. King<sup>18</sup> suggests that the render should be regarded as a thin wall restrained by straw bale at a discrete distance, and the strength model for the concrete column/wall be applied. However that treatment only works if both straw-bale and renders are directly loaded at the top.

In these experiments only straw bales are loaded, the loading applied to the render is indirect through the interaction due to bonding. The maximum allowable values given in both the Pima and California codes are also plotted in Figure 17.

If the ultimate failure load is taken as 73 kN (48.44 kPa for the two-storey wall) and the safe working load is taken as 40 kN (26.55 kPa) when the loading curve ‘softens’ significantly, this gives an equivalent safety factor of 1.82. When compared with both the Pima and California codes, their safety factors are equivalent to 2.81 (Pima code) and 2.51 (California’s code), respectively.

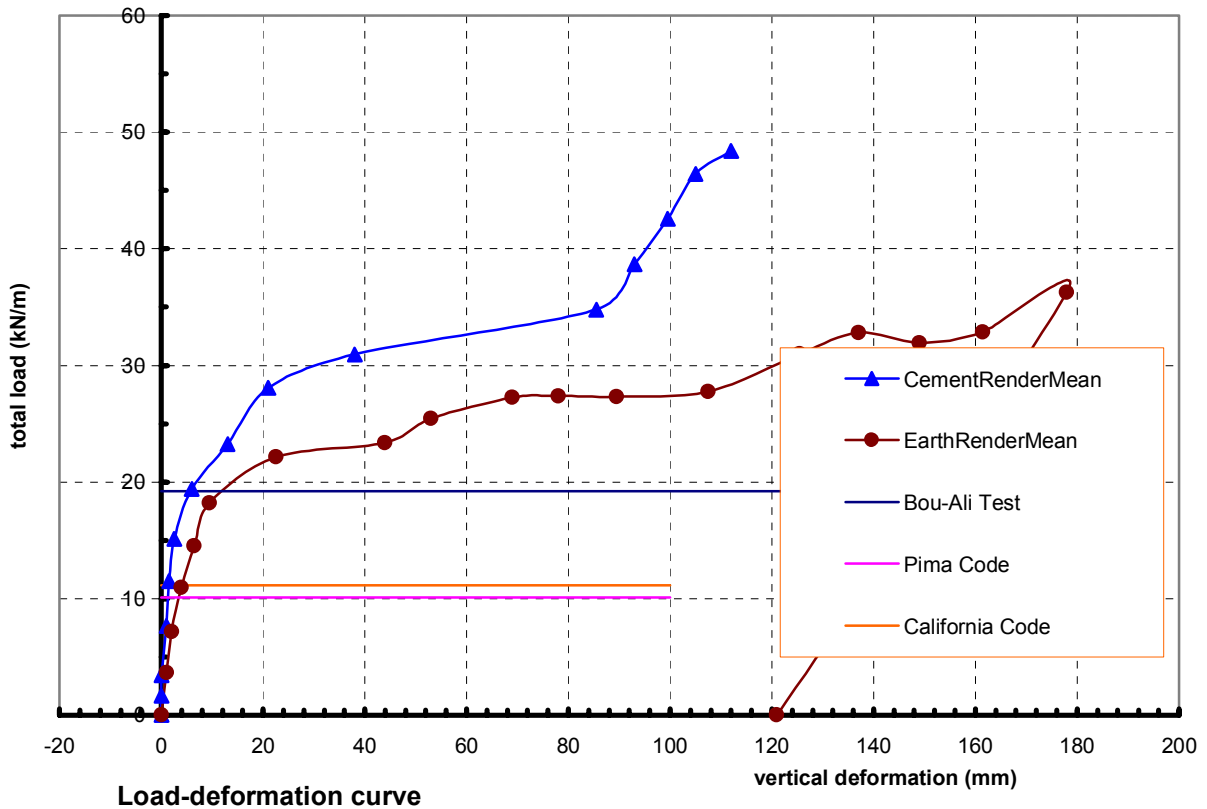
Figure 18 plots the total load against vertical deformation for both walls. Both walls have similar curve properties with the earth render wall failing at a lower total load when compared to the cement render wall. However both walls compare quite well to the limits imposed by both the Pima and California Code.

**Figure 18:** Total load per metre wall versus vertical deformation. (Source J Zhang.)

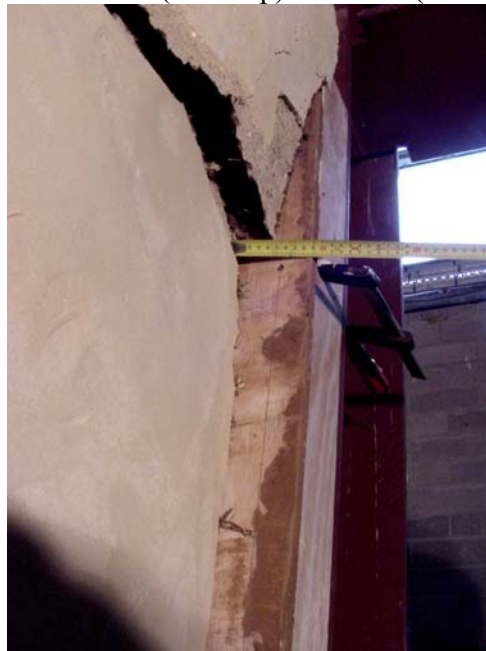
Similarly for the earth render wall test the top plate had rotated out of plane inducing horizontal cracking on one side of the wall with a vertical crack to the other face. Figure 20 is a photograph of the earth rendered wall after the test. The wall has deflected in about 90mm as the top plate has rotated over.

**Figure 20:** View of earth rendered wall (near top) after test (Source S. Overmeyer)

Care needs to be taken to avoid using bales that may induce some 'rotation' to the wall top plate. Both walls showed some significant rotation of the top plate, however in practice this may be constrained by the action of the roof frame members.

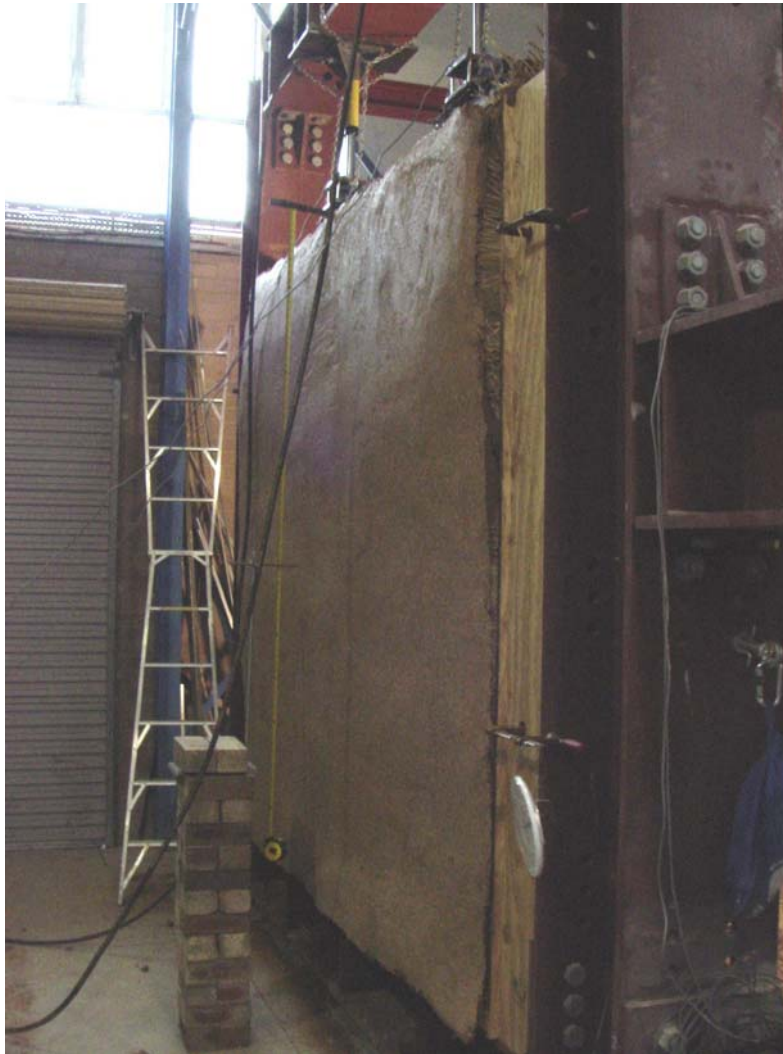
**Figure 21:** General view of the earth rendered wall in test frame. (Source S.Overmeyer)
