## STRAW BALE HOUSE MOISTURE RESEARCH

**Introduction**

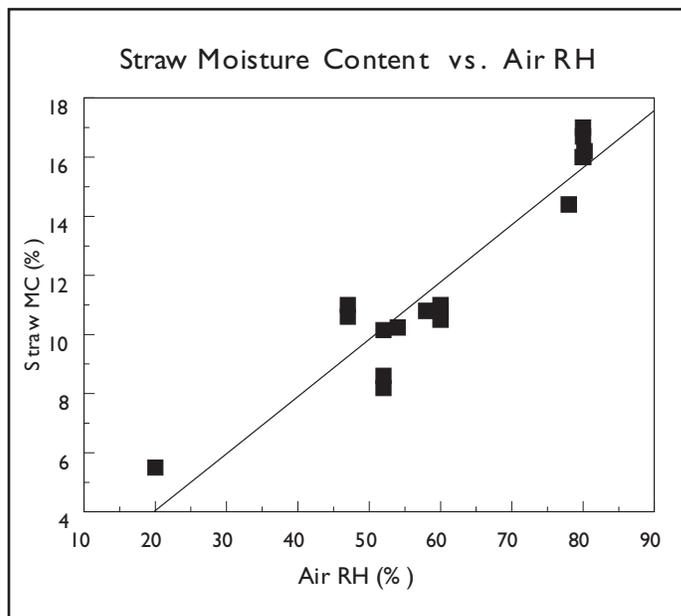
The September readings were generally lower than those at midsummer, at around 11 per cent. These wood moisture contents in Nova Scotia are roughly the same as the air relative humidities as measured in Alberta. See the graph below for a conversion.

The Nova Scotia results showed similar trends. Researcher Shawna Henderson monitored the Nova Scotia houses using wood blocks and wood moisture meters. All readings, for the middle of bale walls, averaged 10 per cent wood moisture content in May and 12 per cent in July, with a few excursions above 15 per cent.
