# A Pilot Study examining the Strength, Compressibility and Serviceability of Rendered Straw Bale Walls for Two Storey Load Bearing Construction.

Michael Faine and Dr. John Zhang  
University of Western Sydney, Australia

**ABSTRACT:** A pilot study of a wall constructed from straw bales was carried out. The objective was to examine the suitability of such walls for two-storey residential construction. The emphases were placed on the strength, compressibility and serviceability of the rendered straw bale wall. The full-scale wall was tested to failure in laboratory conditions. The result shows that it is feasible to construct a two-storey wall using such system. The test results were compared with the recommendation provided by some of the codes of practice. It was found that the wall has adequate capacity for a two-storey wall construction. Other issues, such as constructability, detailing, and compressibility were also examined in this paper.

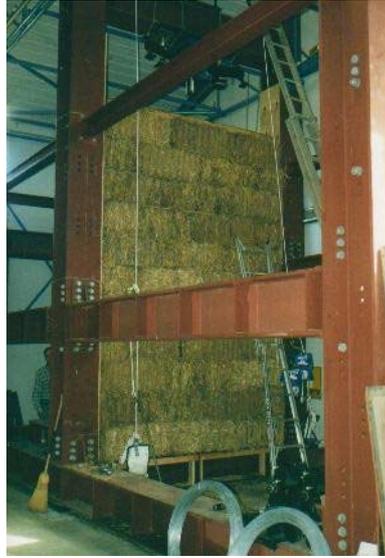
Figure 1 General view of steel test frame and partly completed wall (Photograph: P. Florence)

This picture shows the partly completed wall at the 8th course level contained within the steel reaction frame. A layer of 17mm thick structural plywood was added to this course and pinned to the bales. This was done to help stabilise the wall.

The University of Western Sydney has a well-equipped construction laboratory with a very large steel reaction frame originally developed for the testing of steel and steel/concrete composite columns under axial load up to 100 tonnes. This frame was used to contain the construction of the straw bale wall. Figure 1 shows the general frame arrangement with the partly completed straw bale wall framed between the large structural steel columns. The steel beams and columns were fabricated from 25mm thick steel, 400 x 400mm "I- beam" section, courtesy of a research grant and BHP steel sections.

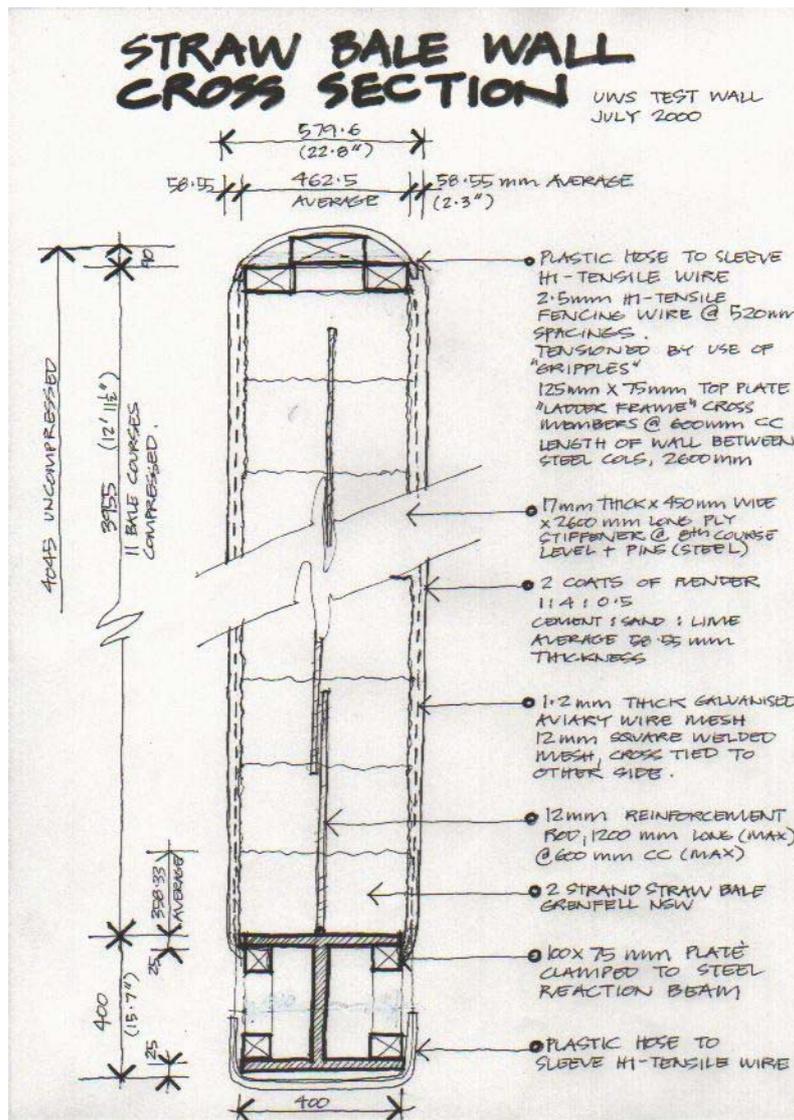
Figure 2. Straw Bale Wall Cross-Section. (Illustration M. Faine)

The wall was constructed to a height of 4045mm (uncompressed) being 11 courses in height; the length of the wall was 2600mm between steel columns with a layer of 17mm structural plywood placed against the steel columns to prevent the straw from expanding into the web of the columns. The general arrangement for construction can be seen in Figure 2. Bales were laid in stretcher bond pattern with a number of half bales. Bales were pinned over a 12mm reinforcement rod that had been tack weld to the frame. Pinning was continued up through the bales to the top course. The lower section of steel was assumed to simulate the concrete footing. A timber infill frame was constructed between the flanges of the bottom steel beam to allow for fixing of the wire mesh. Construction generally followed details reviewed from the literature and from interviews (Mitchell R.)<sup>12</sup>

The top plate was constructed from 125 x 75mm timber joined together as a ladder frame. An additional length was placed centrally to help distribute the load from the hydraulic rams. The high tensile fencing wire was run as a loop under the “footing” and carried up and over the top plate. A length of galvanised iron angle was placed at both top and bottom plates to provide for a radius turn for the wire to prevent a sharp edge from cutting the wire under load. This can be seen in Figure 3.

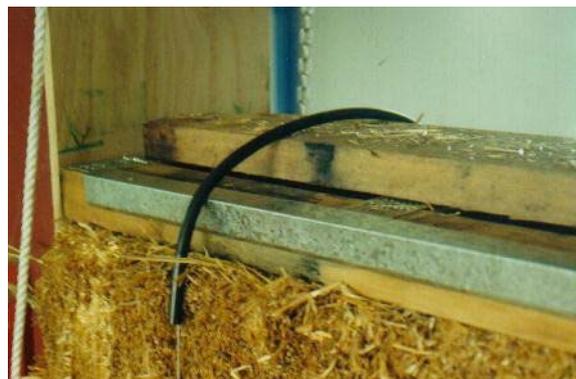
Figure 3: View of top plate assembly showing sleeved wire loop. (Photograph P. Florence)

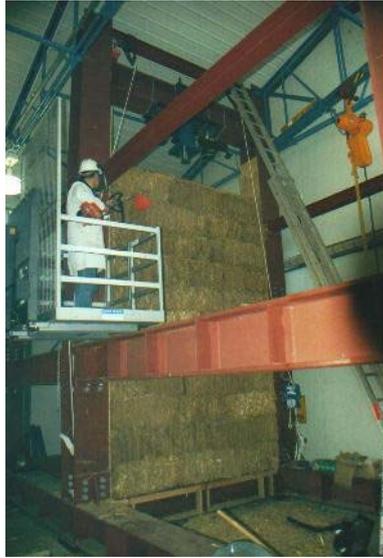
Figure 4: Trimming wall to size. (Photograph P. Florence)

The wall was trimmed to remove stray fibres and nocked into a reasonable straight line prior to the wall being compressed. Once the team was satisfied with the result the rendering process began. Two coats were applied over a period of two weeks, with the coats being applied in about a day and a half by a team of four (inexperienced) renderers. The mix design was 1: 4: 0.5 being cement: sand: lime. This was a strong mix with the addition of the lime to 'self heal' any later cracking. The rendering process can be seen in Figure 5.

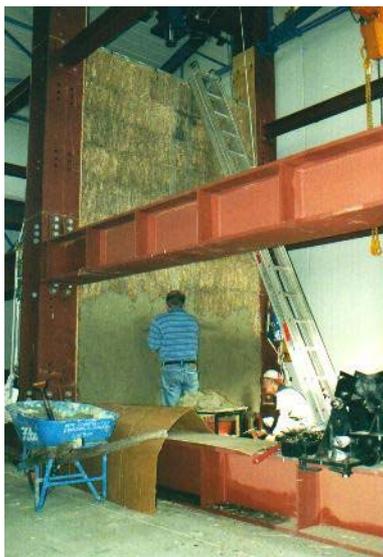
Figure 5: Render application over mesh and straw bales. (Photograph P. Florence)

This was a tedious part of the process and very labour intensive. Our research funds did not extend far enough to warrant using a spray application (this process alone would have accounted for approximately 25% of our funds). Render was applied to an average depth of approximately 60mm.

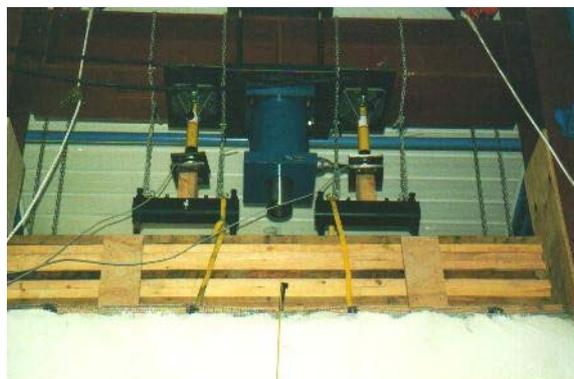
Figure 6: Hydraulic rams and top plate assembly. (Photograph P. Florence)

The test set up was fairly simple. Two 10 tonne capacity Enerpac hydraulic rams were coupled together and attached to the top steel reaction frame. 2 x 10 tonne load cells (HBM Agezelle) were placed in between the ram and steel spreader bars designed to distribute the load at 450 mm centres were stacked on top of the plate. The general arrangement can be seen in Figure 6.

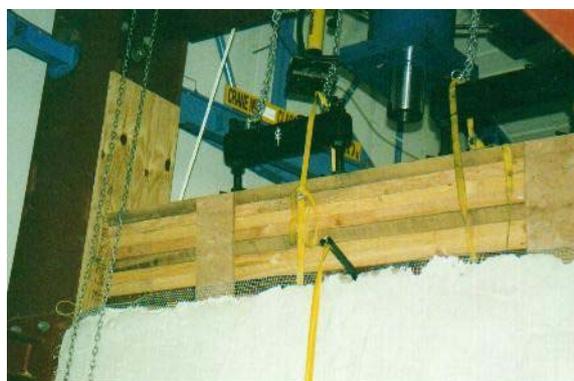
Figure 7: View of top plate, ram and measuring tape. (Photograph P. Florence)

The load cells were calibrated and the two electronic display units were set up to give a read out of the load from each hydraulic ram in newtons. During the test the readout from each unit would be noted against time and deflection/deformation of the wall. A steel scale had been attached to either side of the wall at the midpoint and this was to be read against a static point set up from the floor of the laboratory. Figure 7 shows the steel scale attached to the top plate and Figure 8 shows the other end of the tape and the data acquisition units.

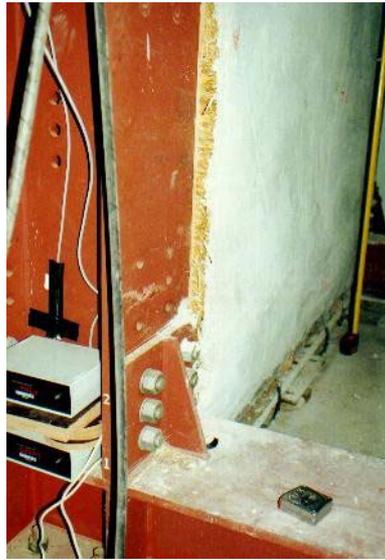
Figure 8: View of electronic display units and end of tape. (Photograph P. Florence)

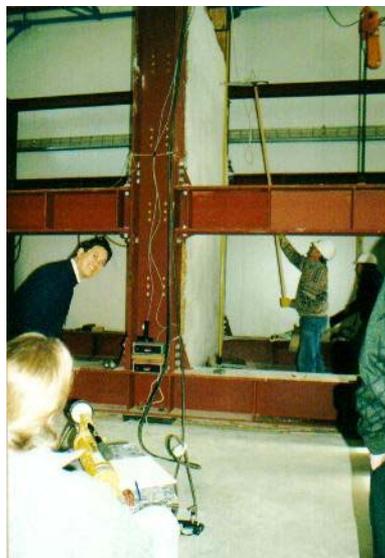
Figure 9: View of lateral measurement process. (Photograph P. Love)

Two theodolites had also been set up to observe readings from pre-designated marked positions on the face of the walls to observe any lateral movement. Figure 9 shows how these measurements were to be taken and recorded as the loading progressed. These measurements were recorded to determine if the wall had moved sideways during the loading process.

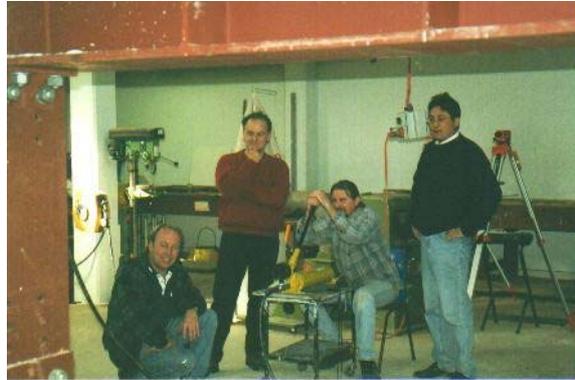
Figure 10 records some of the team members in action. The hand pump can be clearly seen with the theodolites set up in the background.

Figure 10: Some of the test crew in action. (Photograph P. Love)

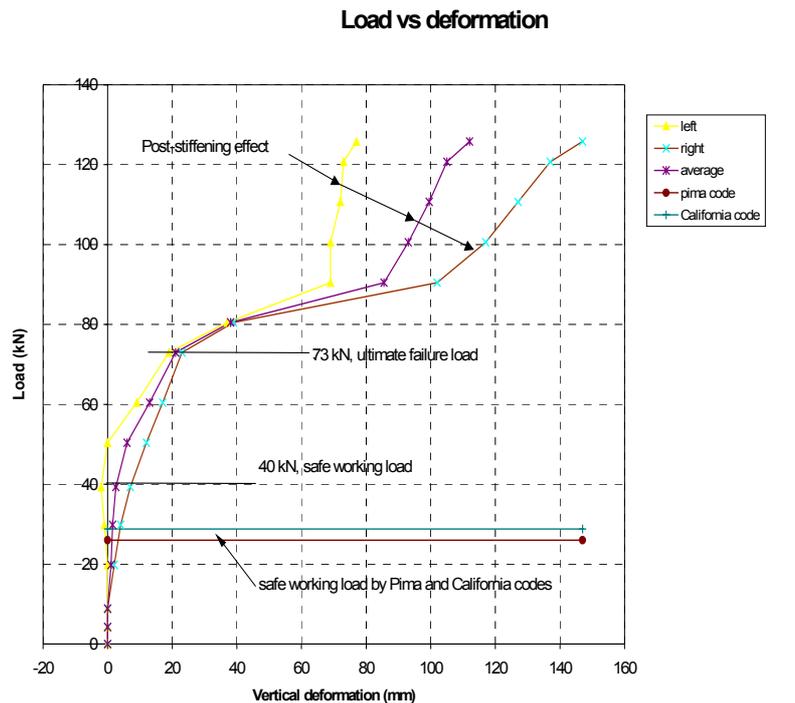
The results of this table have been shown in the following chart (Figure 13.)

Figure 13 Load Deformation Curve (Source J. Zhang)

The wall demonstrated some interesting and fascinating structural characteristics. Apart from the obvious failure region when the load reaches about 80 kN, it also reveals that the post-failure behaviour has a distinct feature of post-stiffening effect due to the compressibility of the material.

When the wall is first loaded, the behaviour follows a typical linear path. The left side deformation reading is negative indicating it is moving upward instead of downward as one would expect. This is due to the eccentricity in the applied load and in the wall itself. This eccentricity creates a significant bending effect so that the wall is bent toward the right hand side.

For this reason the average deformation between the left and right provide a more meaningful interpretation of the result. It can be seen on the average curve at the load level of just above 40 kN, there is a significant increase in deformation, demonstrated by the change of slope in the curve. One would stipulate that due to the compression of straw bale, the interaction between the straw and the cement render becomes less significant resulting in the 'softening' of the wall. As the load increases the wall starts to 'yield'. At the load level of 70 kN there is a significant increase in deformation, which marks the failure of the wall. This failure is probably due to the significant separation between the straw bale and the cement render. As the load increases further, the straw bale becomes fully compressed, therefore becoming more solid as the load starts to increase further. Although this post-failure capacity cannot be used in the design of straw bale wall, it does illustrate that the post-failure behaviour is rather stable.

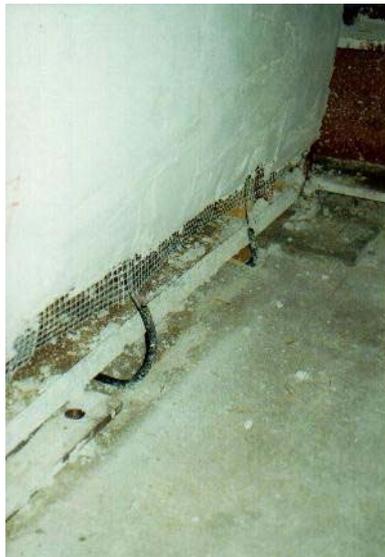
Figure 14. View of bottom plate after test (Photograph P. Florence)

The wall did not fail as expected; most of the team were anticipating that the wall would buckle under load with parts of the render falling away from the face of the wall. In fact very little cracking was observed to have formed in the face of the wall. Both faces of render had acted like a 'curtain' and followed the compression of the wall. This can be clearly seen in Figure 14, a view of the bottom plate of the wall. The high tensile wire loop has become slack and has fallen as the wall had compressed, the render has stayed remarkably intact on both faces.

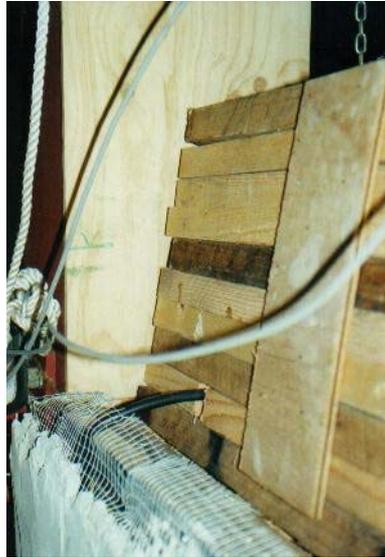
Figure 15. View of top plate after the test. (Photograph P. Florence)

The top plate had twisted progressively under load and possibly would have ‘tumbled over’ if the test had been continued.

The top plate was also observed to have rotated during the test. It is possible that the load was slightly off centre or that the straw was less stiff on one side. Another possibility could be that

the wall was not perfectly plumb and square when constructed but was within reasonable limits for a bale wall. Figure 15 records a view of the top plate after the test.
