LOAD-BEARING STRAW BALE CONSTRUCTION

A summary of worldwide testing and experience

June 30, 2003

Bruce King, PE

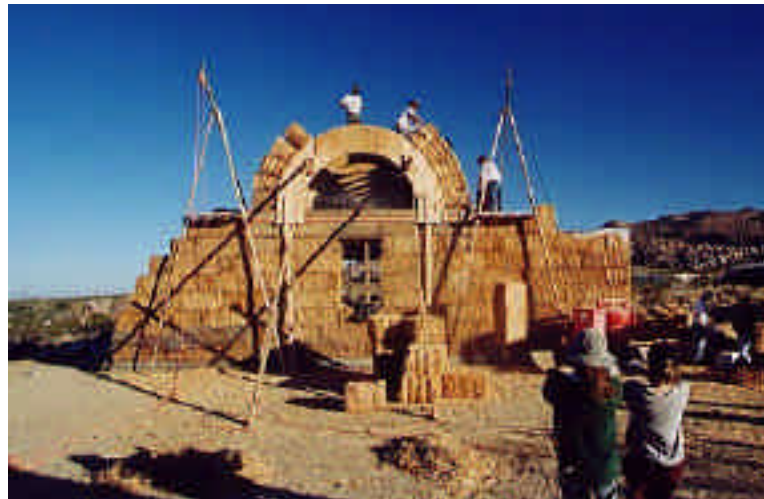
Straw-bale barrel vault house under construction, Joshua Tree, California. Design and photograph by Skillful Means Construction. Recipient of the 2002 Innovative Seismic Design of the Year Award from the Structural Engineers' Association of California; engineering by David Mar, Tipping-Mar Associates.

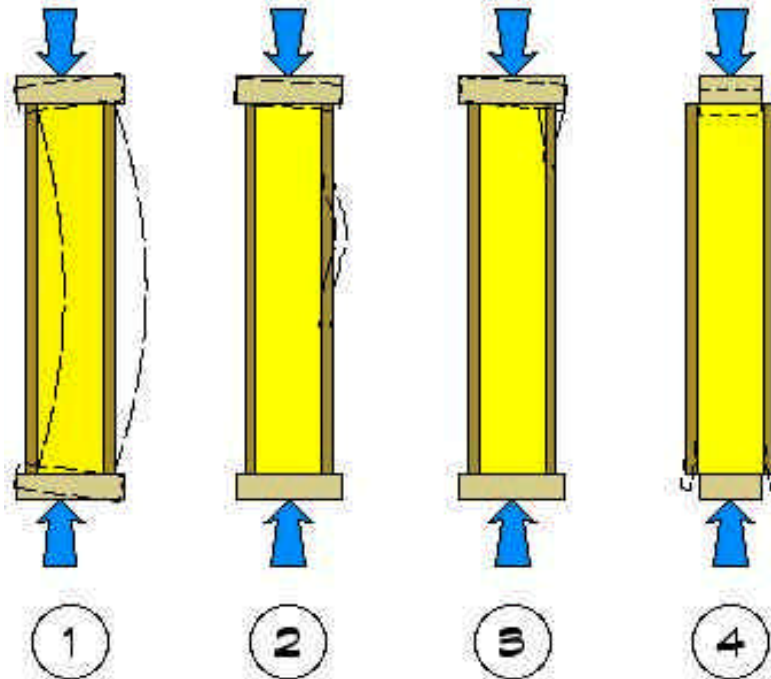
Figure 2: Failure modes for a load-bearing straw bale wall

- 1. Global buckling** the whole wall bends and breaks—typically when the wall is well-built, but eccentrically applied load induces bending.
- 2. Local buckling** part of the skin delaminates and pulls off the core, or one coat of plaster delaminates and separates from the coat beneath—the result of poor plaster application causing insufficient bond, and/or surface irregularity causing local bending.
- 3. Bearing** skin crushes under the top or bottom plate, and/or top or bottom plate crushes under edge of skin—the wall components have not been designed or built to sustain the focused stress at the joint.
- 4. Slippage** unsupported skin slips past the top or bottom plate—typically, a failure of fasteners attaching mesh to the sides of plates or beams.

Notes: It has been widely noted that, contrary to expectation, the 18” walls carried substantially more load than the 24” walls, and were stiffer. Though there were some irregularities in load application, and in the quality of plastering, this dramatic difference has yet to be fully explained or understood. Every possible failure mode was seen among the nine specimens (see figure 2),
